Our Reference : PE/CH/D116285/SMR

Date: 4th April 2008

**A27 Bridge Road, Sarisbury Green, Gas Pipeline
 Long term monitoring and testing of SMR treated trench arisings**

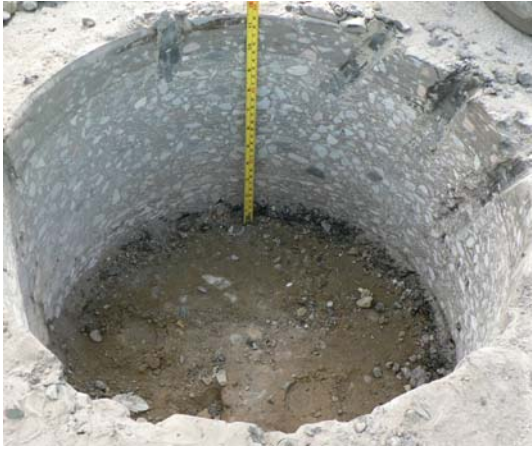
- The bond between the SMR and bottom of bituminous bound layer in Location L1 required a mechanical breaker to facilitate removal of the core.
- The bituminous bound layers displayed no evidence of deformation or voids (related to inadequate compaction).
- The SMR surface layers did not display any evidence of cracking, heave or deterioration.
- No free water was evident in any of the core holes.
- The SMR exposed in Location 3 displayed evidence (the material was darker in colour) of having higher water content than Locations L1 and L2. This may be related to the localised loss of surface sealant.

Test location	In situ test			Plates
	GDP (MPa)	LWD (MPa)	Clegg CBR (%)	
L1	Stiffness exceeded the GDP test apparatus working range*	970	140 (123 to 163)

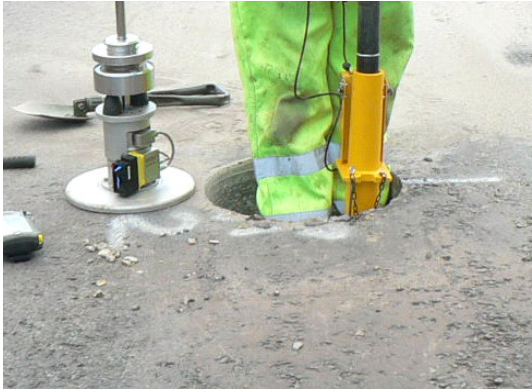
L2		2700	>237 (237 to abort*)

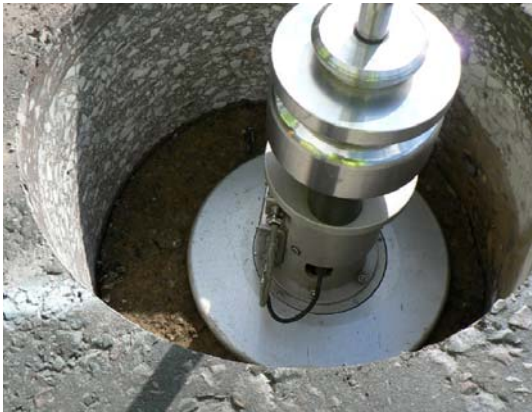
L3		310	45 (43 to 46)

Confirmatory testing indicates a significant improvement, as would be expected from a material which gains strength/stiffness over time, from the initial testing undertaken in 2005. Comparative long term surface modulus values (assuming the material is durable) for a C4 NFSMR (90 day cube value in excess of 4 N/mm²) and Type 1/GSB1 would respectively be around 400 MPa and 120 MPa. These values are guidance only as testing and environmental conditions will influence performance. Where the SMR recorded a surface modulus value of below 400 MPa (310 MPa was recorded in L3), evidence of increased water content was observed (given an indication of a worse case scenario). The absence of slurification or any other sign of deterioration indicates that the SMR has proved durable and that rectification of the surface defect would ensure subsequent performance as a base.
